# **EVALUATION OF HIGH STRENGTH COLUMBIUM ALLOYS FOR ALKALI METAL CONTAINMENT**

**INTERIM REPORT NO. 2**

**Covering the Period  
July 25, 1962 to July 10, 1964**

**SPACE POWER AND PROPULSION SECTION  
MISSILE AND SPACE DIVISION**

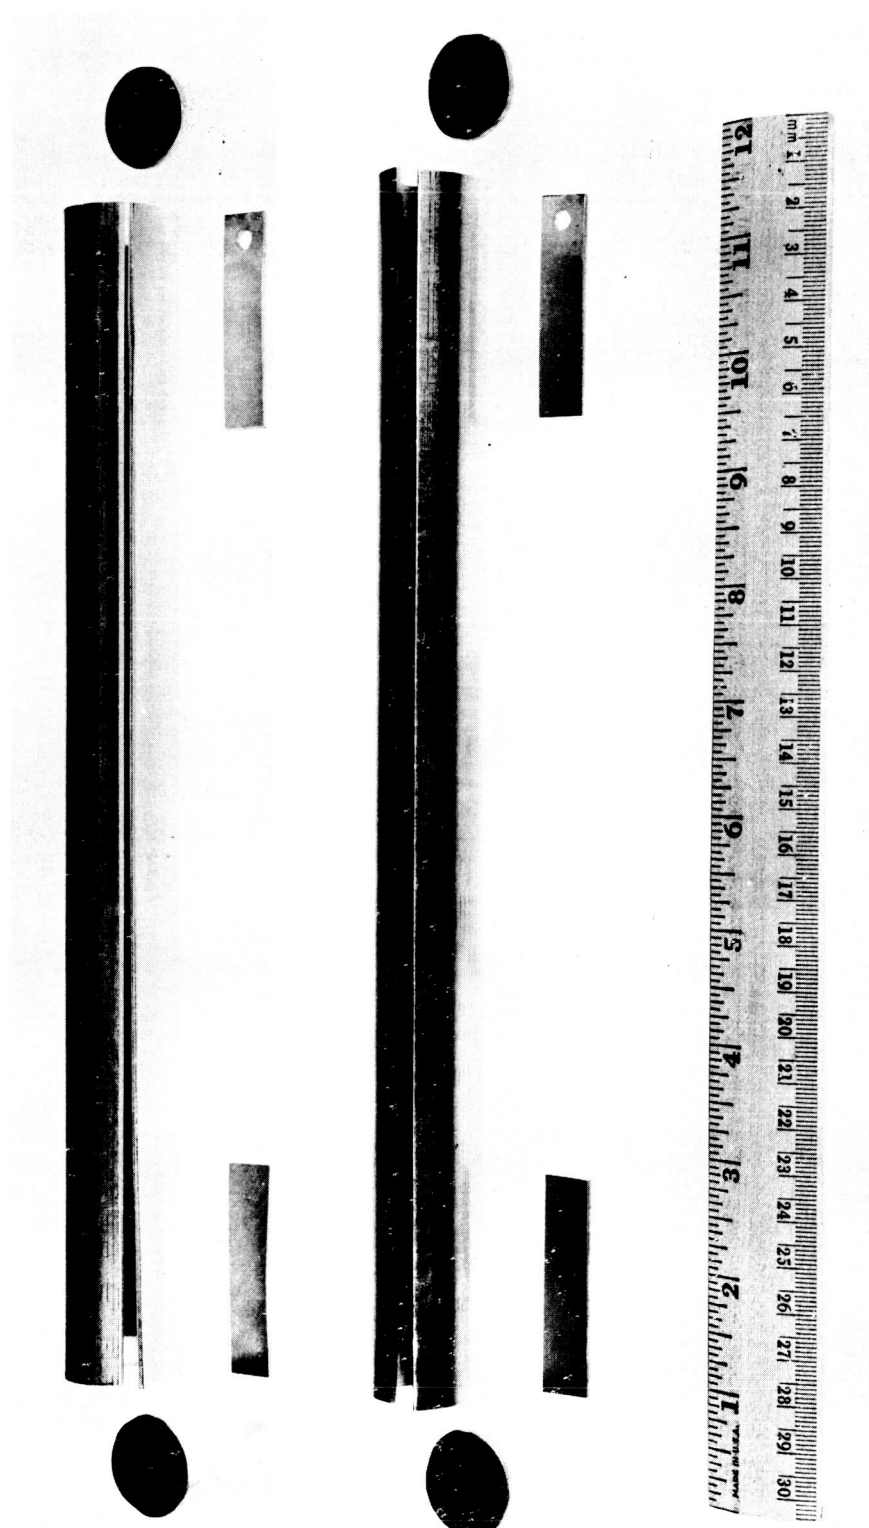
Figure 1. Typical Reflux Corrosion Capsules, End Caps, and Bend Specimens Prior to Assembly and Welding; Top: AS-55 Alloy (C63032016), Bottom: D-43 Alloy (C63032017).

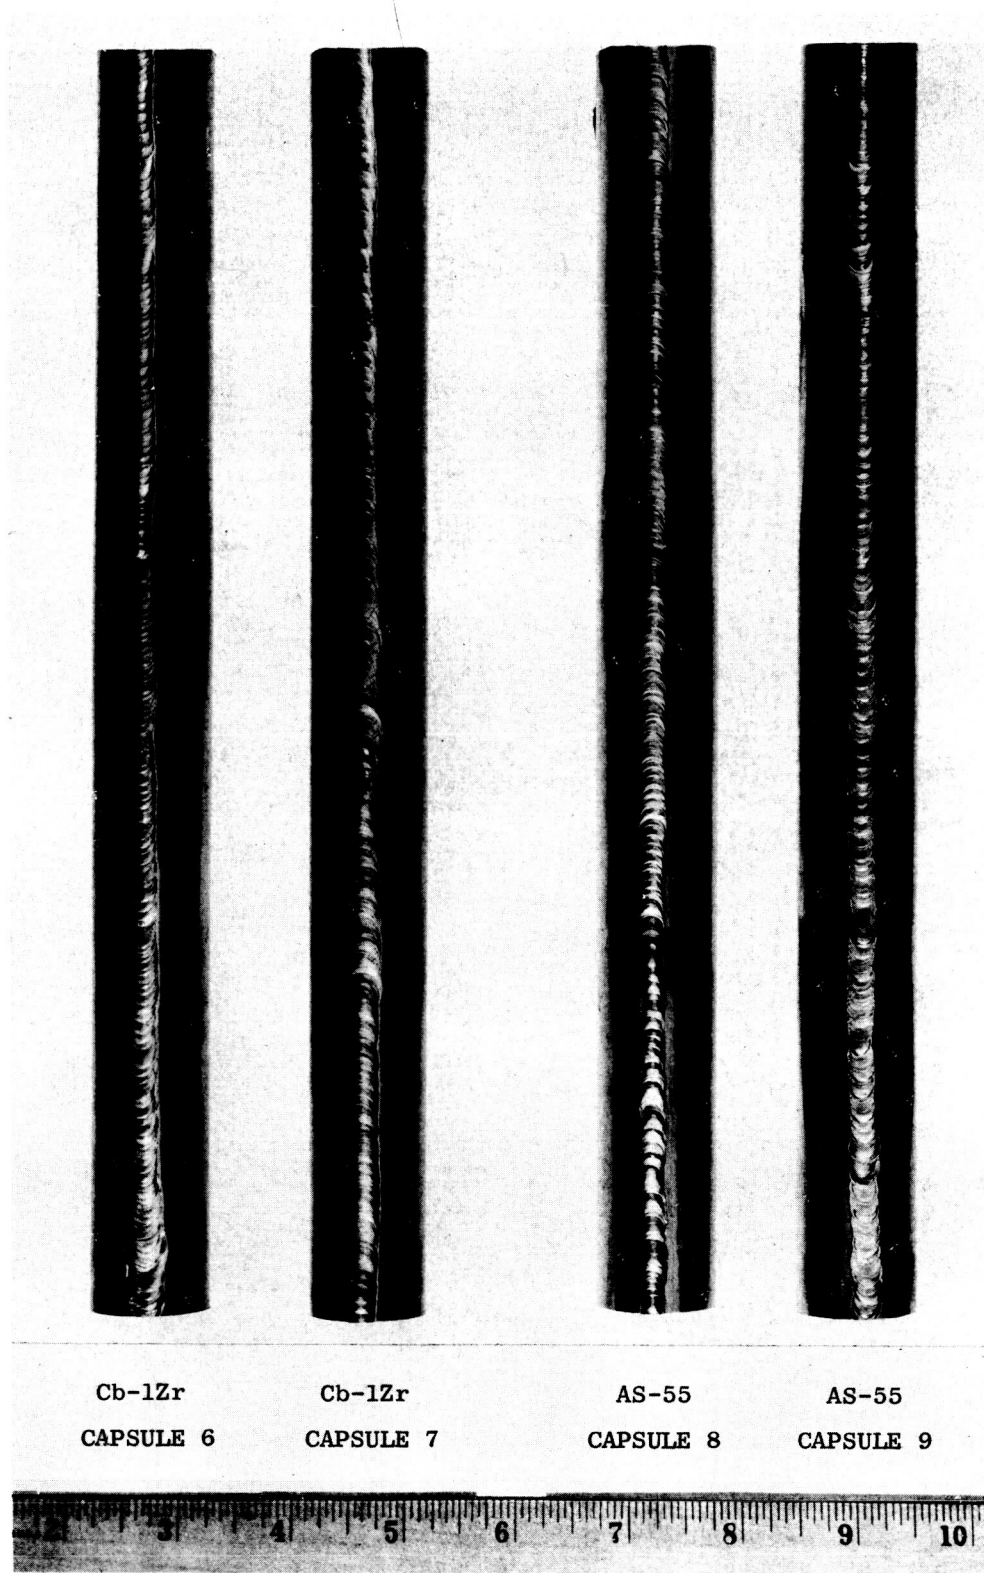
Figure 2. Formed and TIG Welded Reflux Corrosion Capsules of AS-55 and Cb-1Zr Alloys. (C2060126)

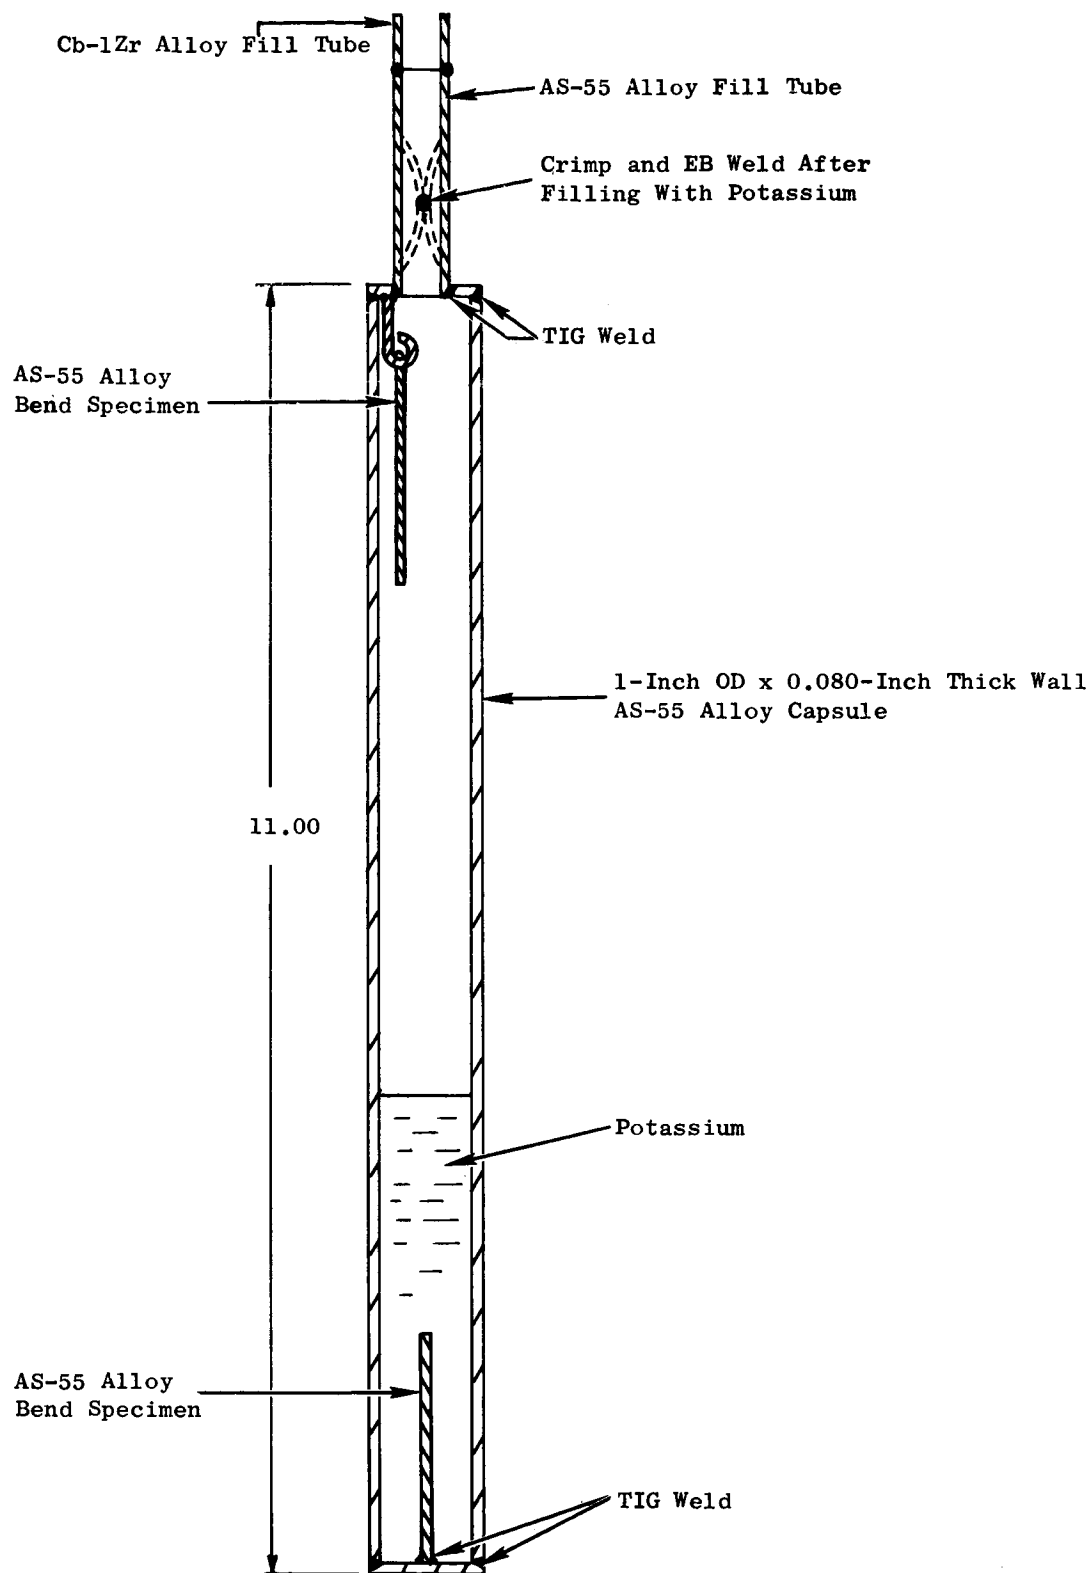
Figure 3. AS-55 Alloy Reflux Corrosion Capsule #8 Showing Fill Tube and Location of Bend Specimens.

All four capsules (#6, #7, #8 and #9) contained 0.080-inch thick x 0.5-inch wide x 2-inch long bend specimens in the liquid and vapor regions as shown in Figure 3. These bend specimens were made from the same material as their respective capsules. The interiors of the capsules, with bend specimens in position, were examined with a borescope and no detrimental defects could be observed in the welds. The capsules were leak checked with a helium mass spectrometer as prescribed in MIL-Std-271B and found to be leak tight. A radiographic examination of the four capsules showed their welds to be sound. A photograph of the Cb-1Zr alloy capsules #6 and #7 and the AS-55 alloy capsules #8 and #9 prior to filling with potassium is shown in Figure 4.

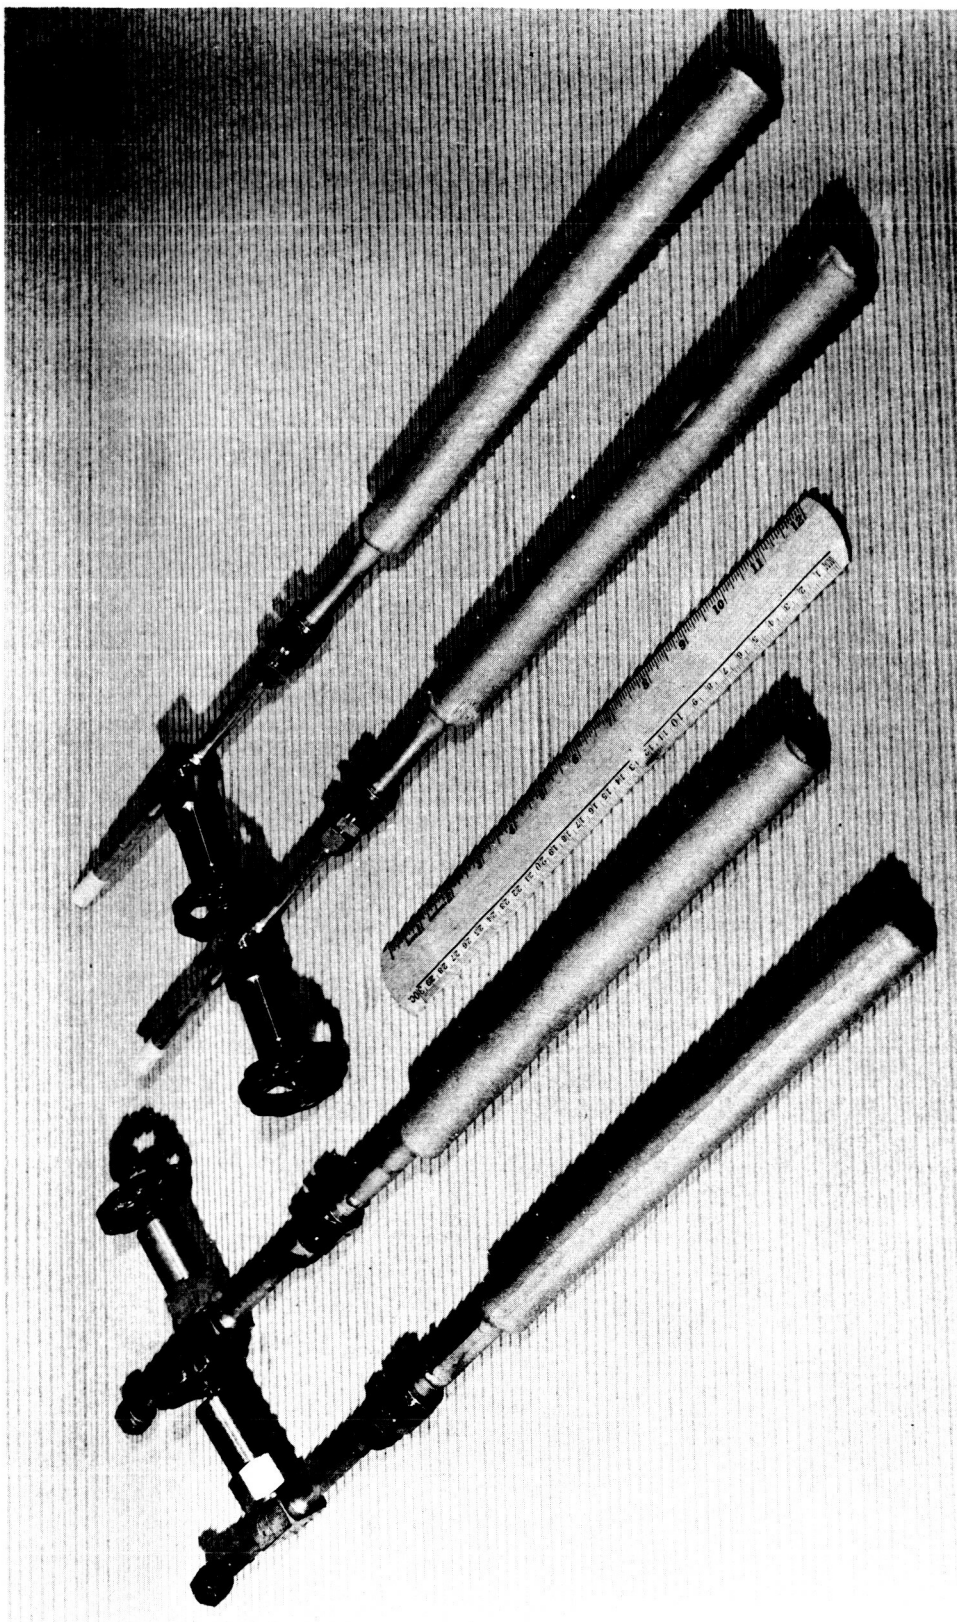
Figure 4. AS-55 Alloy Capsules #8 and #9 (Left) and Cb-12r Alloy Capsules #6 and #7 (Right) Prior to Filling with Potassium.  
(C2050119)

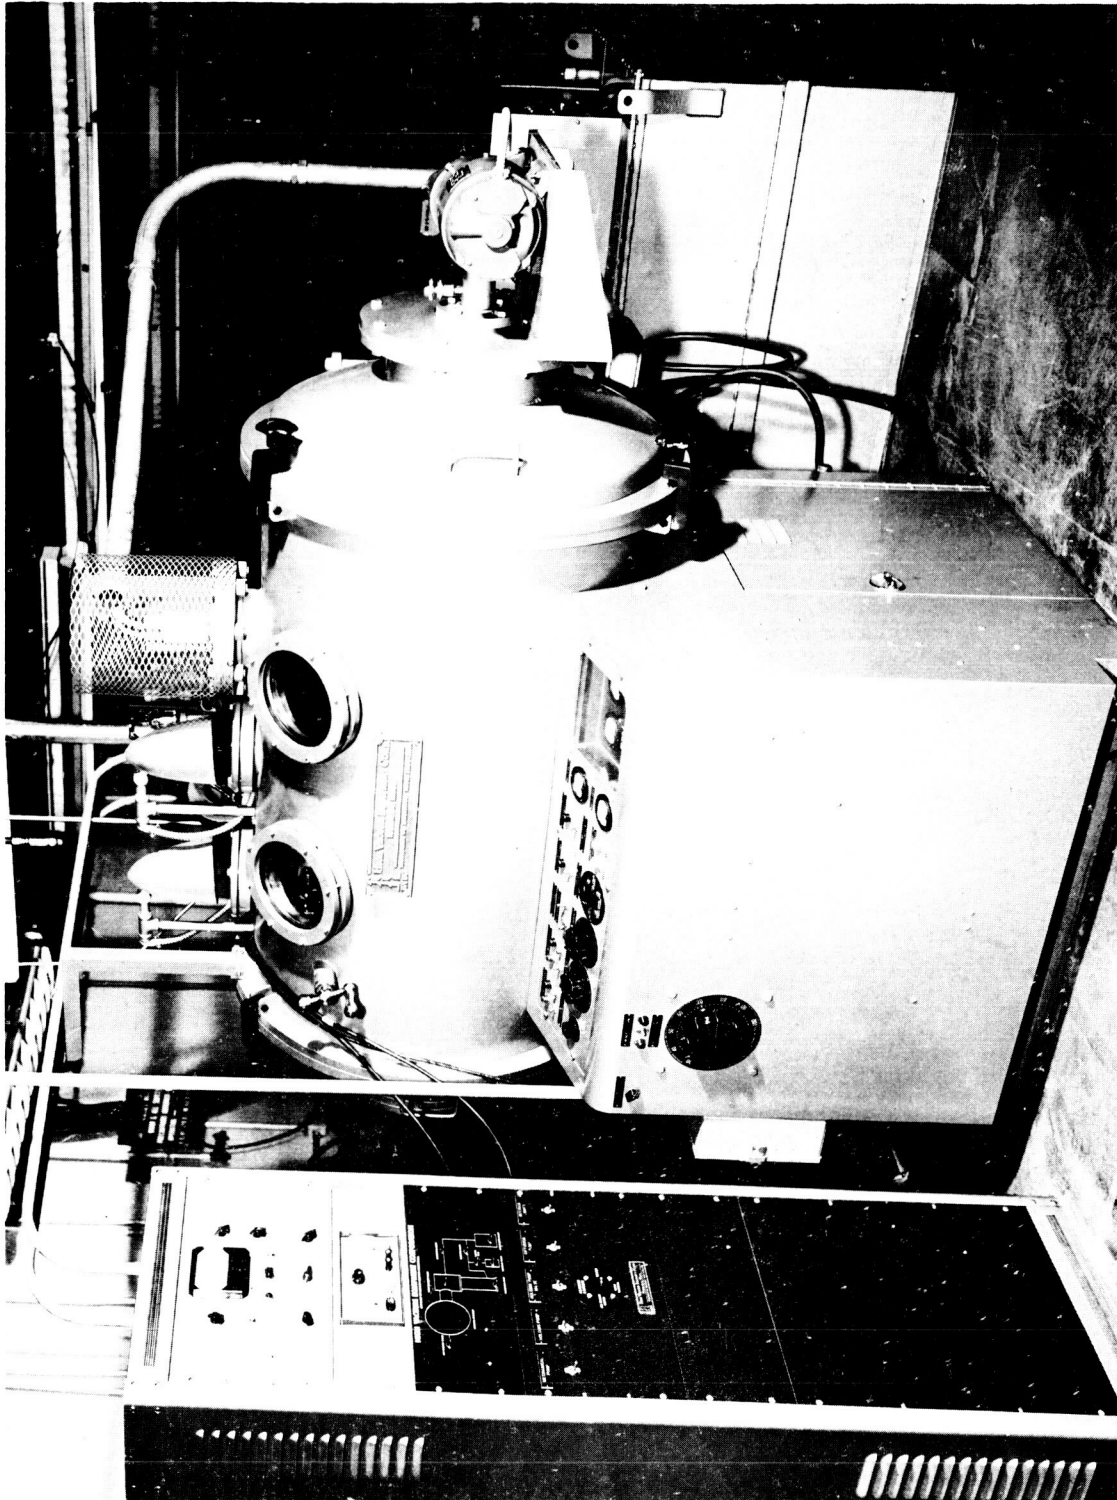
Figure 6. 30 KV Electron Beam Welding Facility. (C1022014)

The potassium transfer facility that was developed is similar to the transfer facility at NASA Lewis Research Center and consists of a 30 KV, electron beam welding chamber, shown in Figure 6, which incorporates facilities for transferring potassium directly from the hot trap to the capsules in a vacuum of  $5 \times 10^{-5}$  torr with a leak rate of 1.4 micron-cubic feet per hour. The pumping system consists of a 10-inch oil diffusion pump and a 80 cfm Stokes Microvac mechanical forepump. The vacuum is measured with a National Research Corporation Type 501 ionization gauge and Model 710B control circuit. Figure 7 shows an external view of the facility with the hot trap in place; Figure 8 shows the general capsule arrangement inside the chamber. The potassium is transferred to the capsules by pressurizing the hot trap, filling the stainless steel ladle with the potassium to the required level (30 grams) and then pouring the potassium through the stainless steel funnel into the capsule

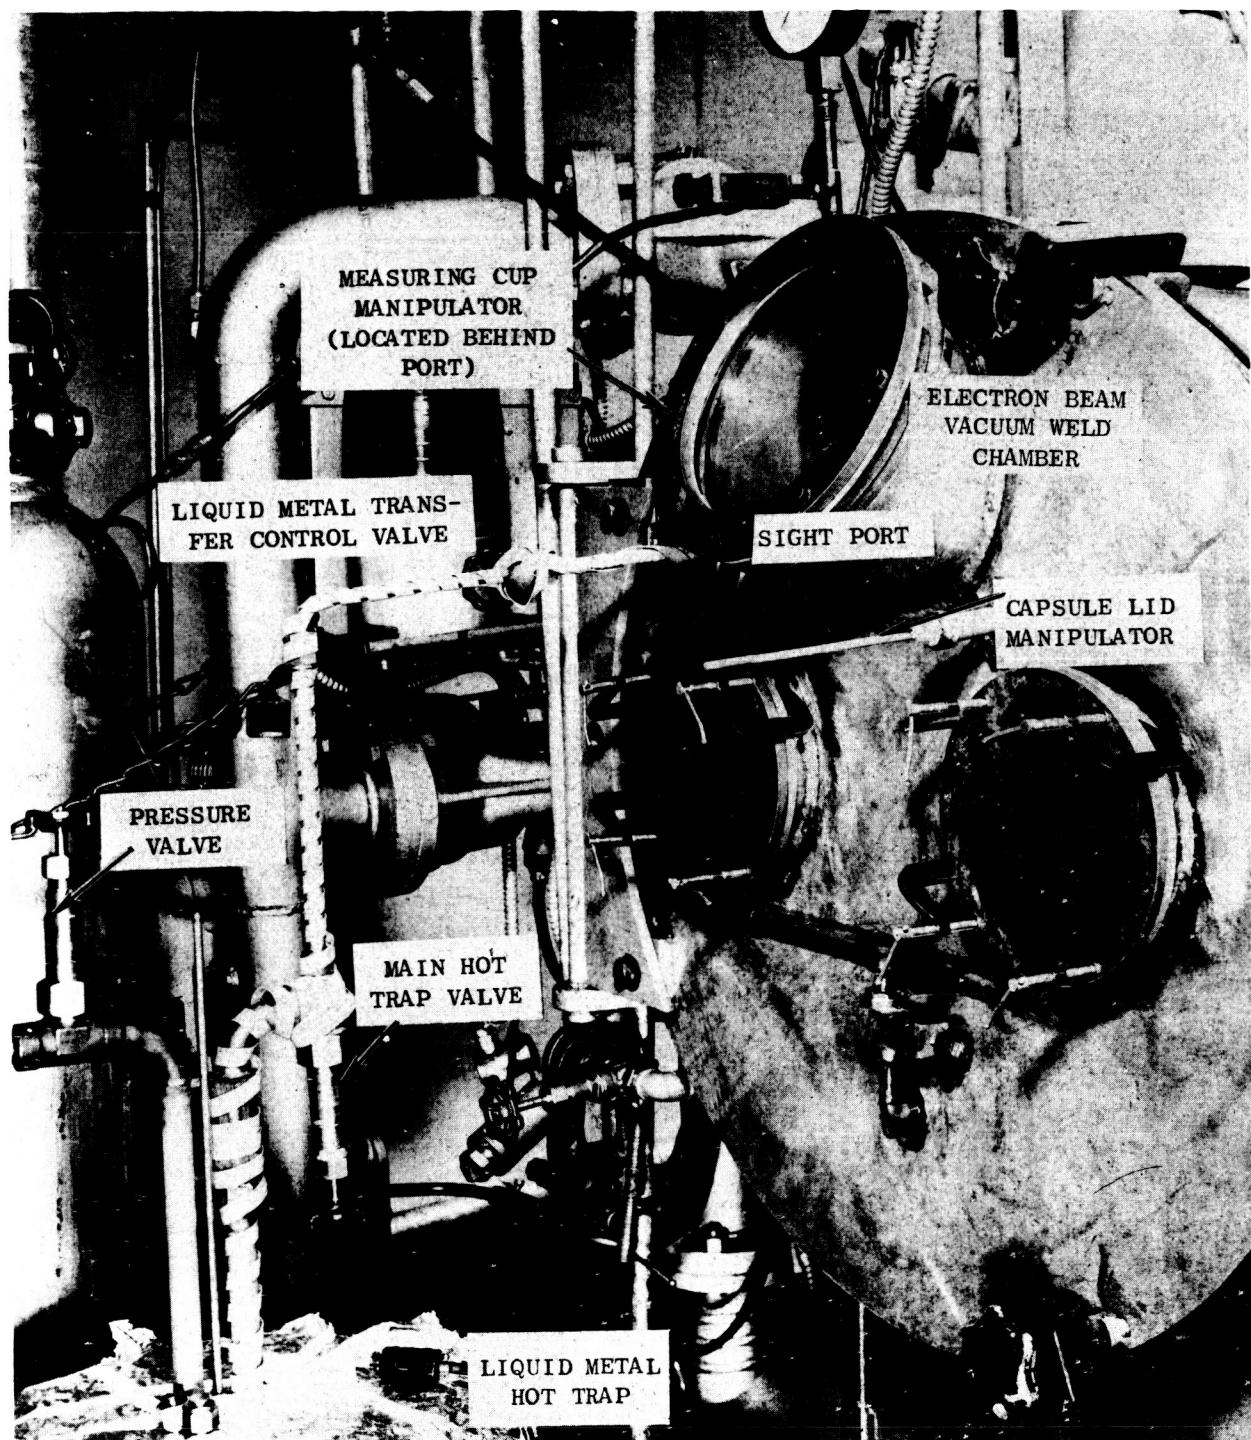
Figure 7. External View of the System for Alkali Metal Transfer. The Hot Trap is Shown Attached to the Vacuum Tank Door. (C63041623)

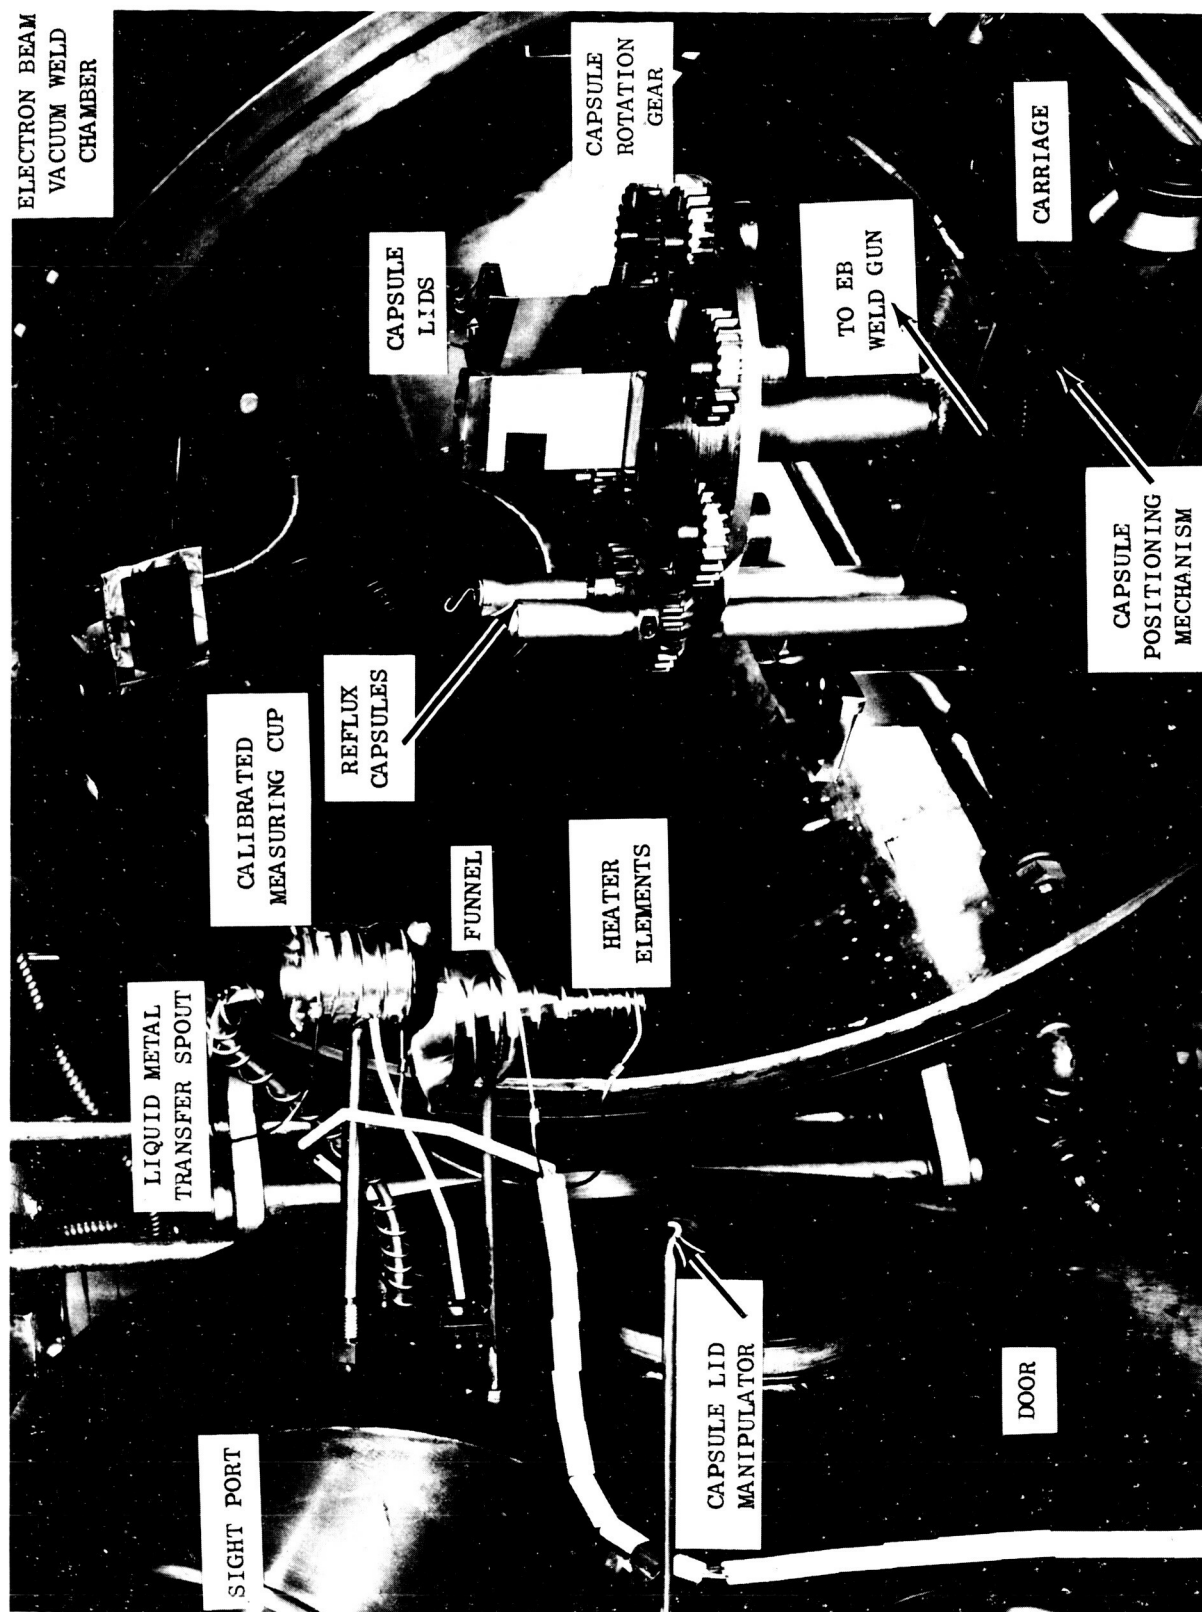
Figure 8. Internal View of System for Alkali Metal Transfer Showing the Necessary Components for Filling of Reflux Capsules. System was Used for Filling Capsules #2, #4, #11 and #12 with Potassium. (C63041622)

using a vacuum rotary feedthrough. After the capsule lid is manually placed on the capsule with the manipulator, the capsule is automatically positioned under the EB gun on the motor driven carriage and the lid is seal-welded to the top of the capsule as the capsule is rotated on its own axis. A series of six capsules can be filled without breaking the vacuum.

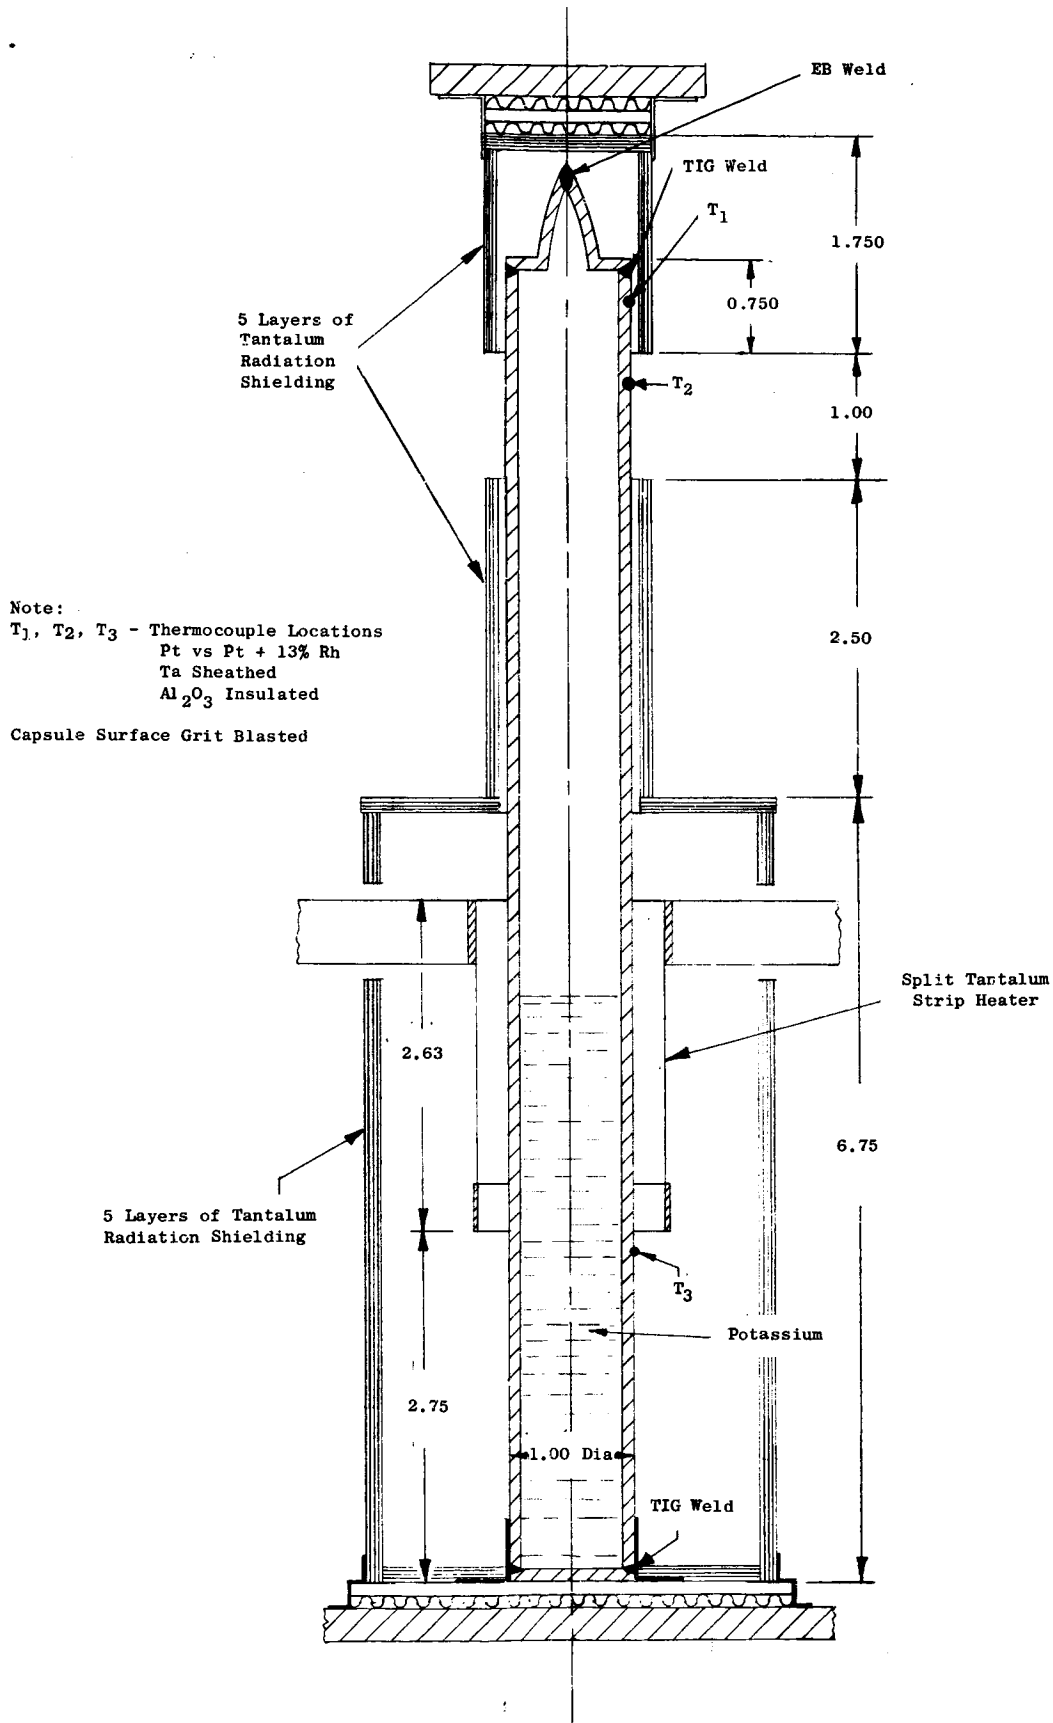
Figure 9. Drawing of Reflux Capsule Illustrating Location of Radiation Shielding, Radiation Zone, Tantalum Heating Elements, and Height of Potassium at Temperature in Capsules #6, #7, #8 and #9.

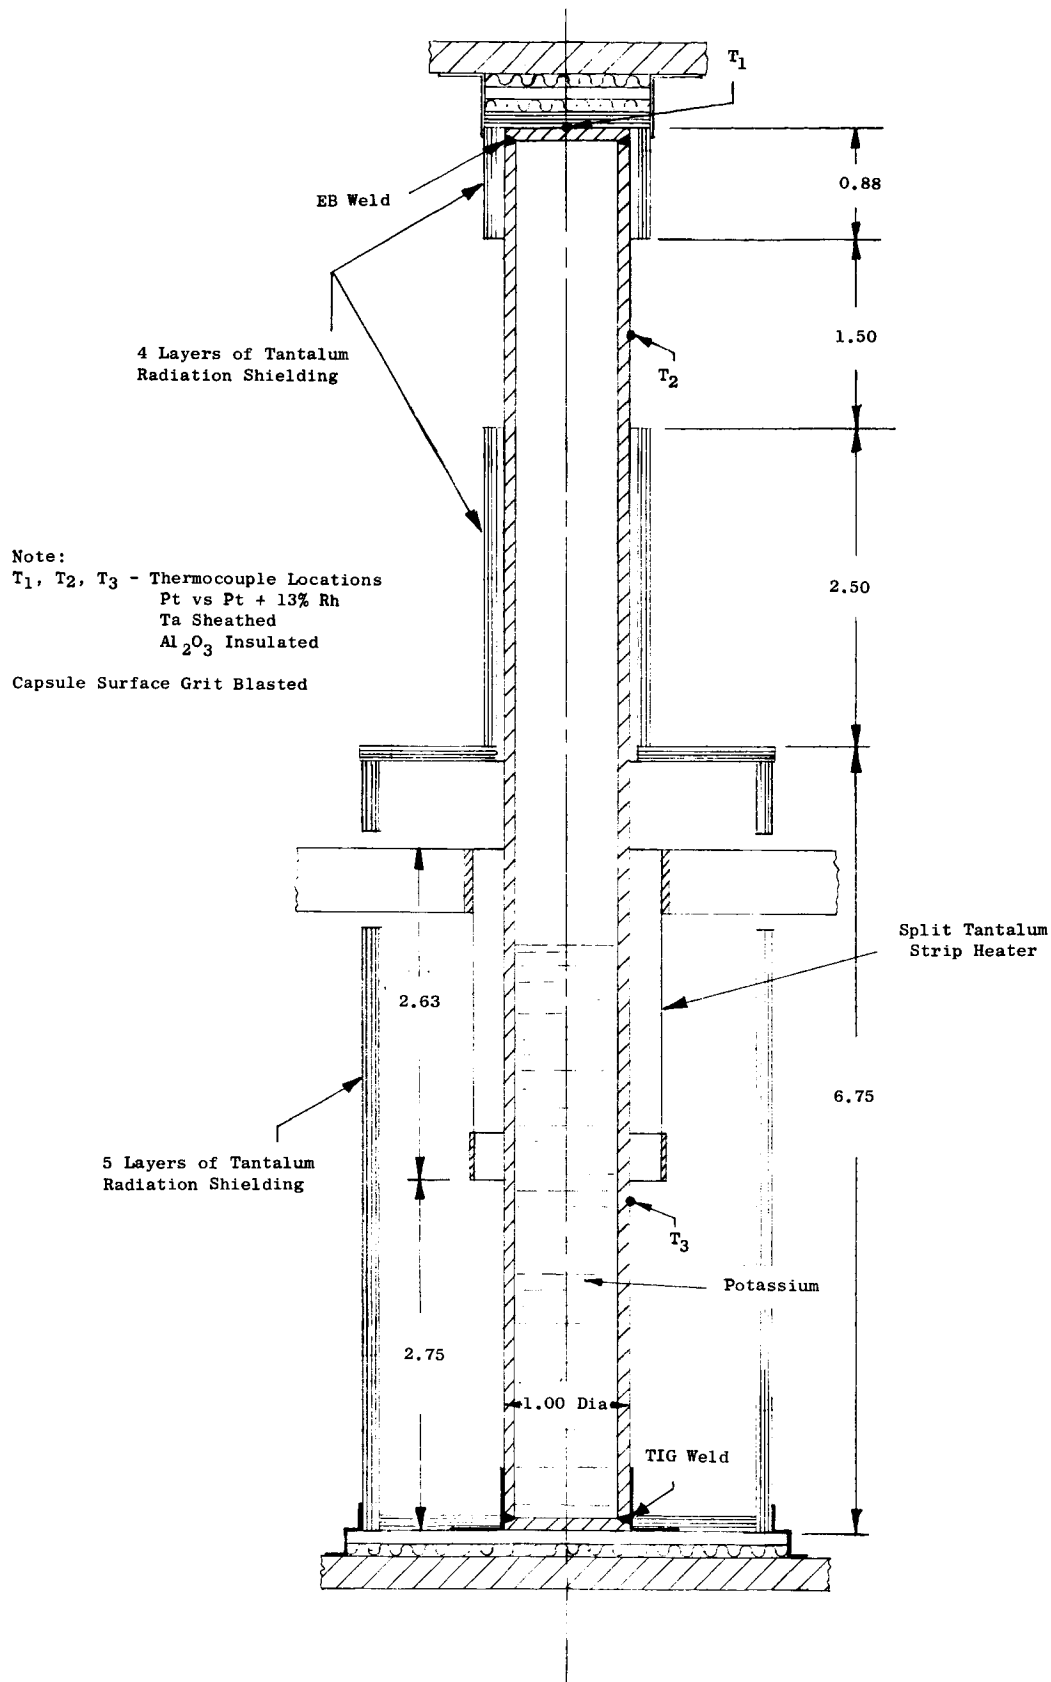
Figure 10. Drawing of Reflux Capsule Illustrating Location of Radiation Shielding, Radiation Zone, Tantalum Heating Element, and Height of Potassium at Temperature in Capsules #2, #4, #11 and #12.

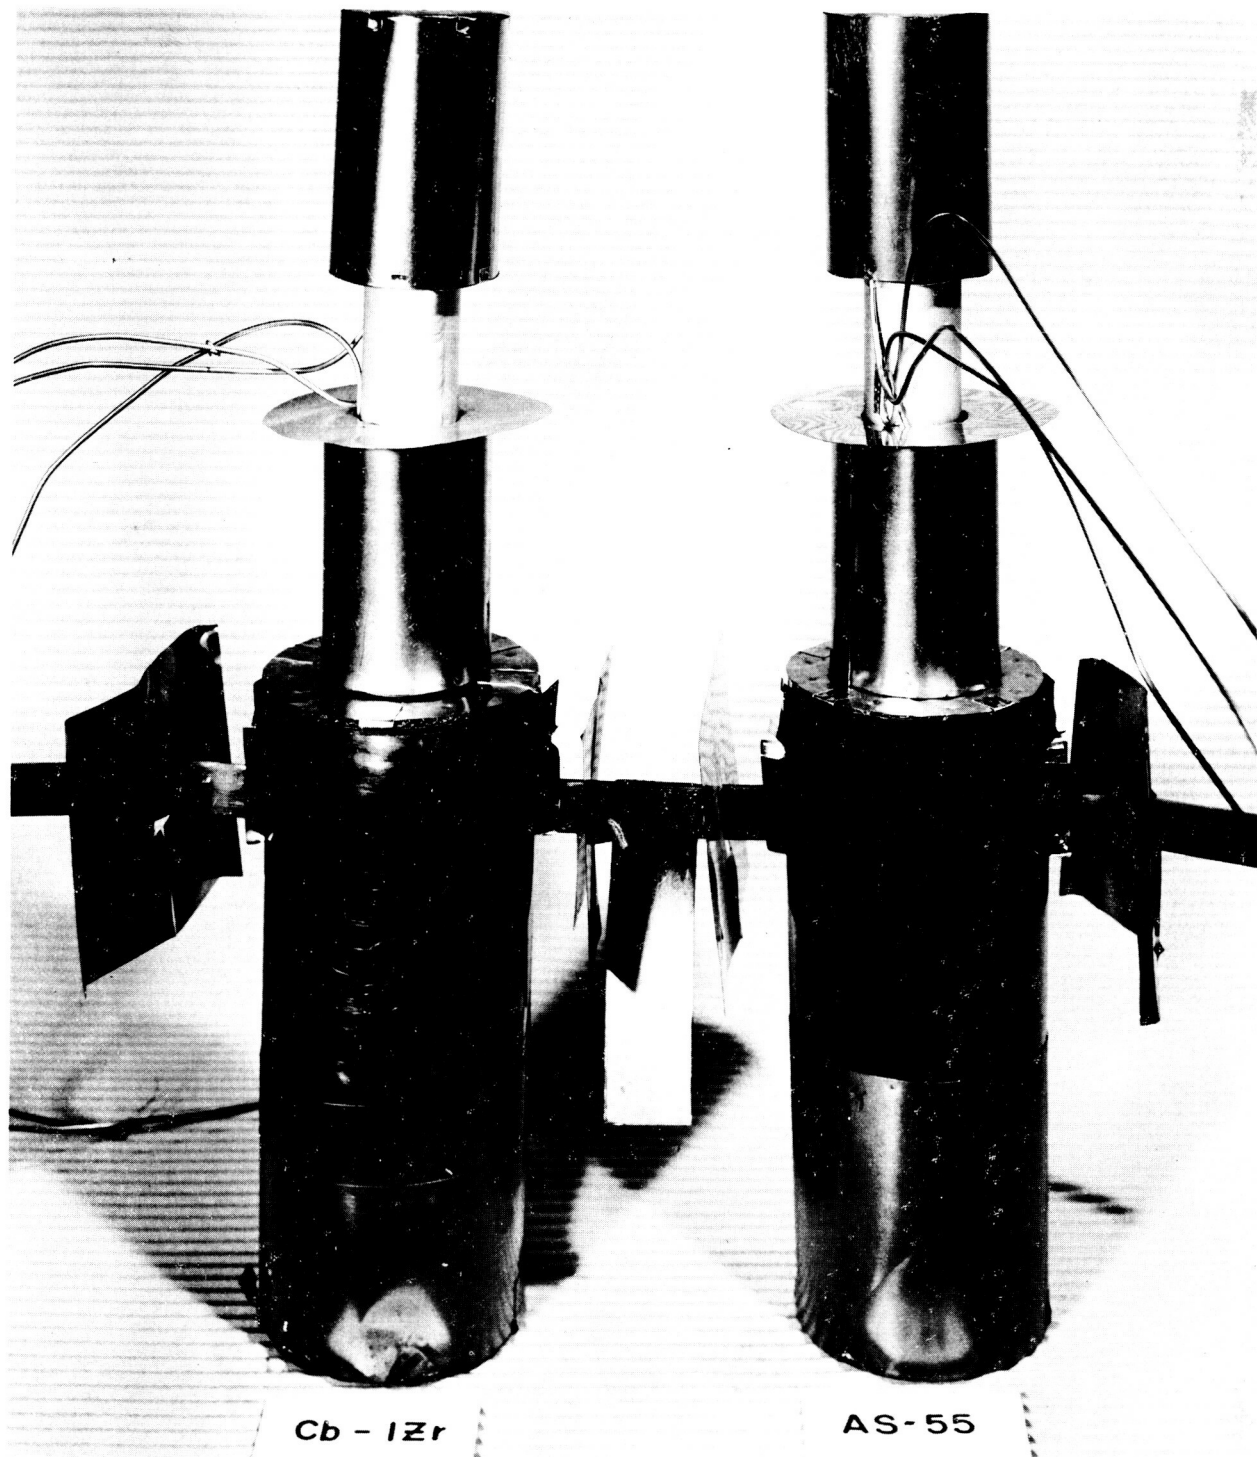
Figure 11. AS-55 and Cb-1Zr Alloy Reflux Corrosion Capsules Containing Potassium and with Tantalum Radiation Heaters and Shielding in Place. (C63052103)

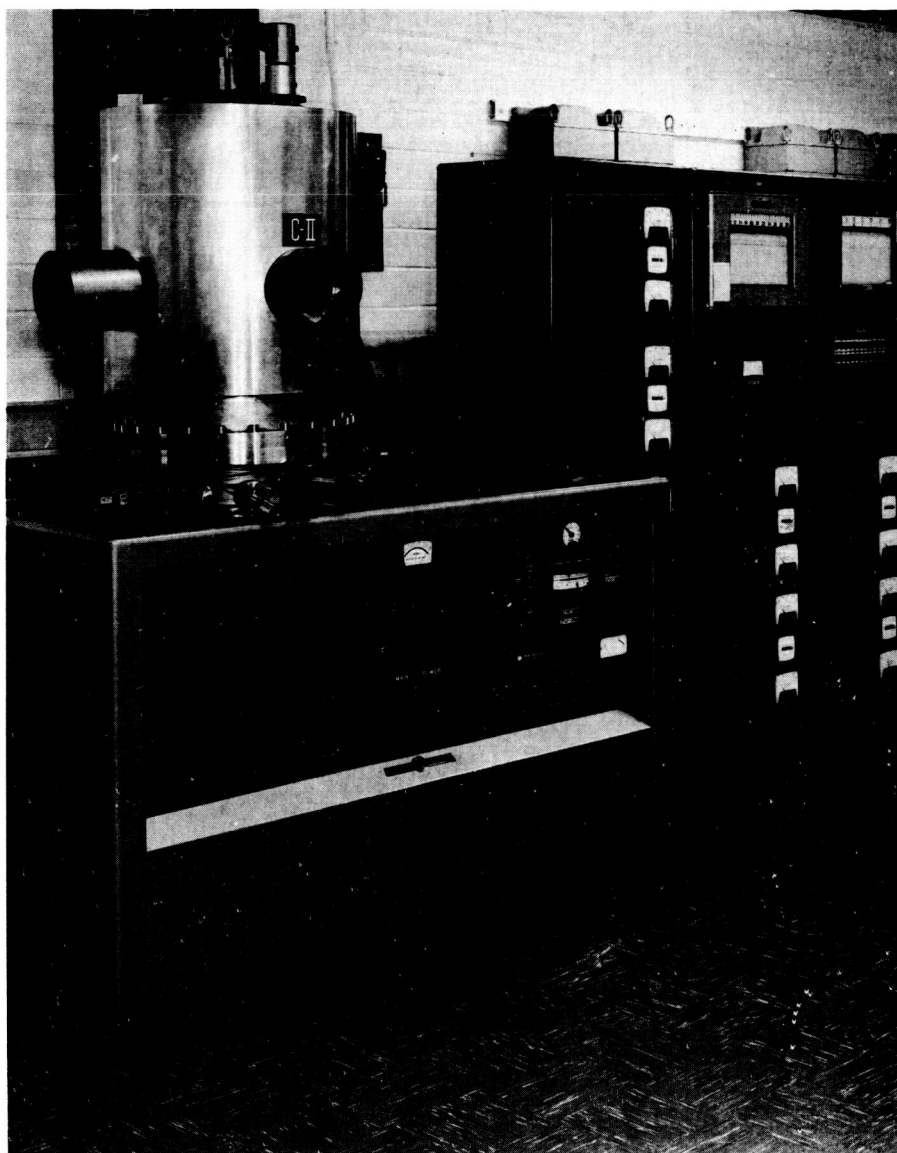
Figure 12. Ultra High Vacuum System' ( $10^{-10}$  Torr Range) Used in the Study of the Corrosion Behavior of AS-55, D-43, and Cb-1Zr Alloys in Potassium. The Chamber is 18 Inches in Diameter and 30 Inches High and Incorporates a 400  $\text{l}/\text{Sec}$  Getter-Ion Pump and 3 Adsorption Pumps. (C64051216)

with the getter-ion pump after a suitable bakeout period. Pressure is measured by a Bayard-Alpert type ionization gauge attached to the side of the chamber.

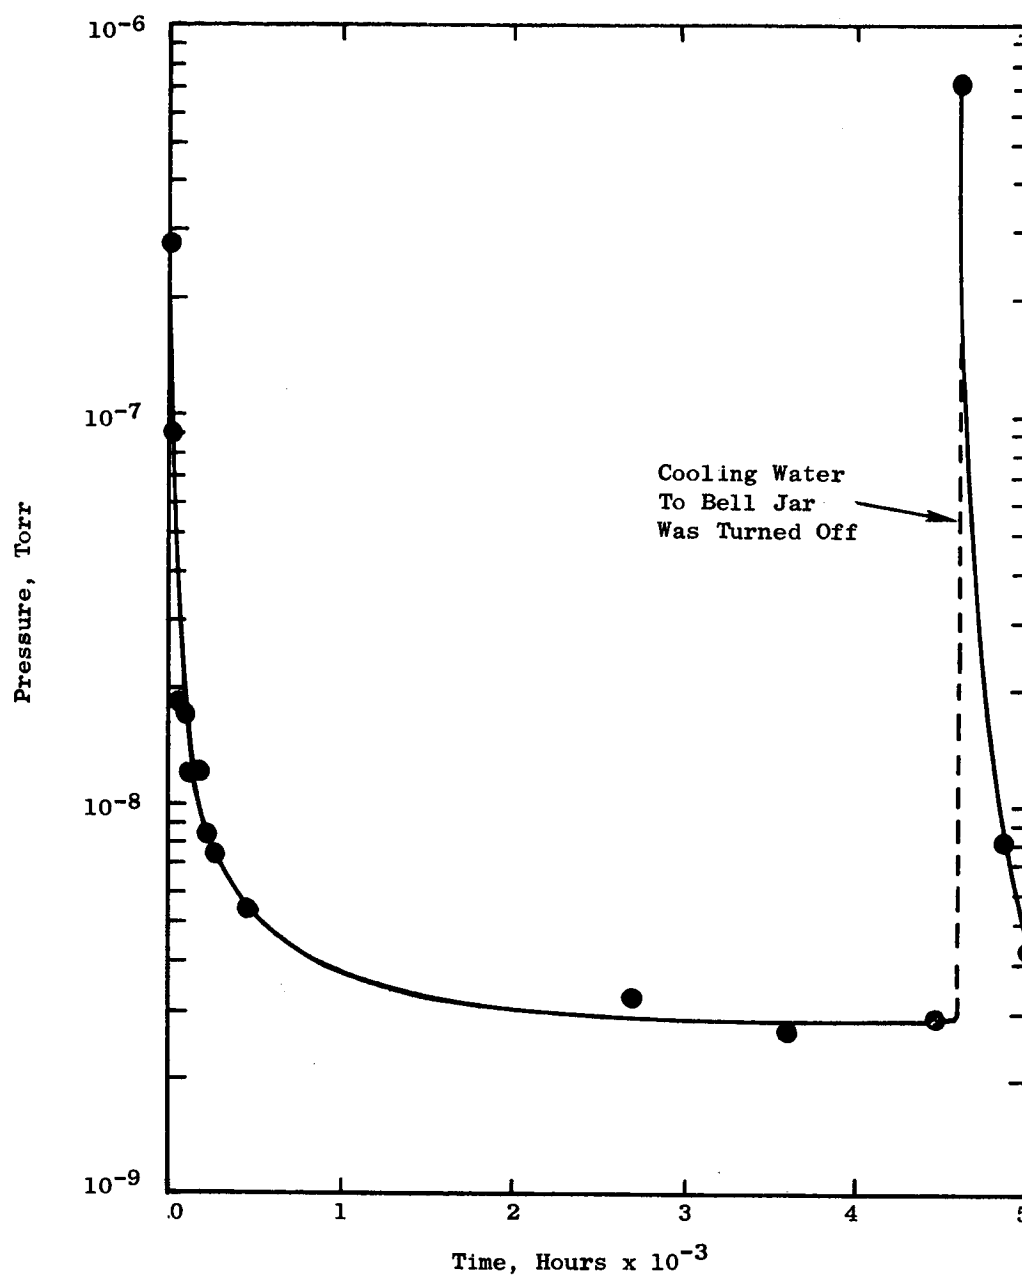
Figure 13. Pressure Profile of High-Vacuum Chamber C-III During Testing of Cb-1Zr Alloy Reflux Corrosion Capsule #6 and AS-55 Alloy Reflux Corrosion Capsule #8 at 2000°F for 5,000 Hours.

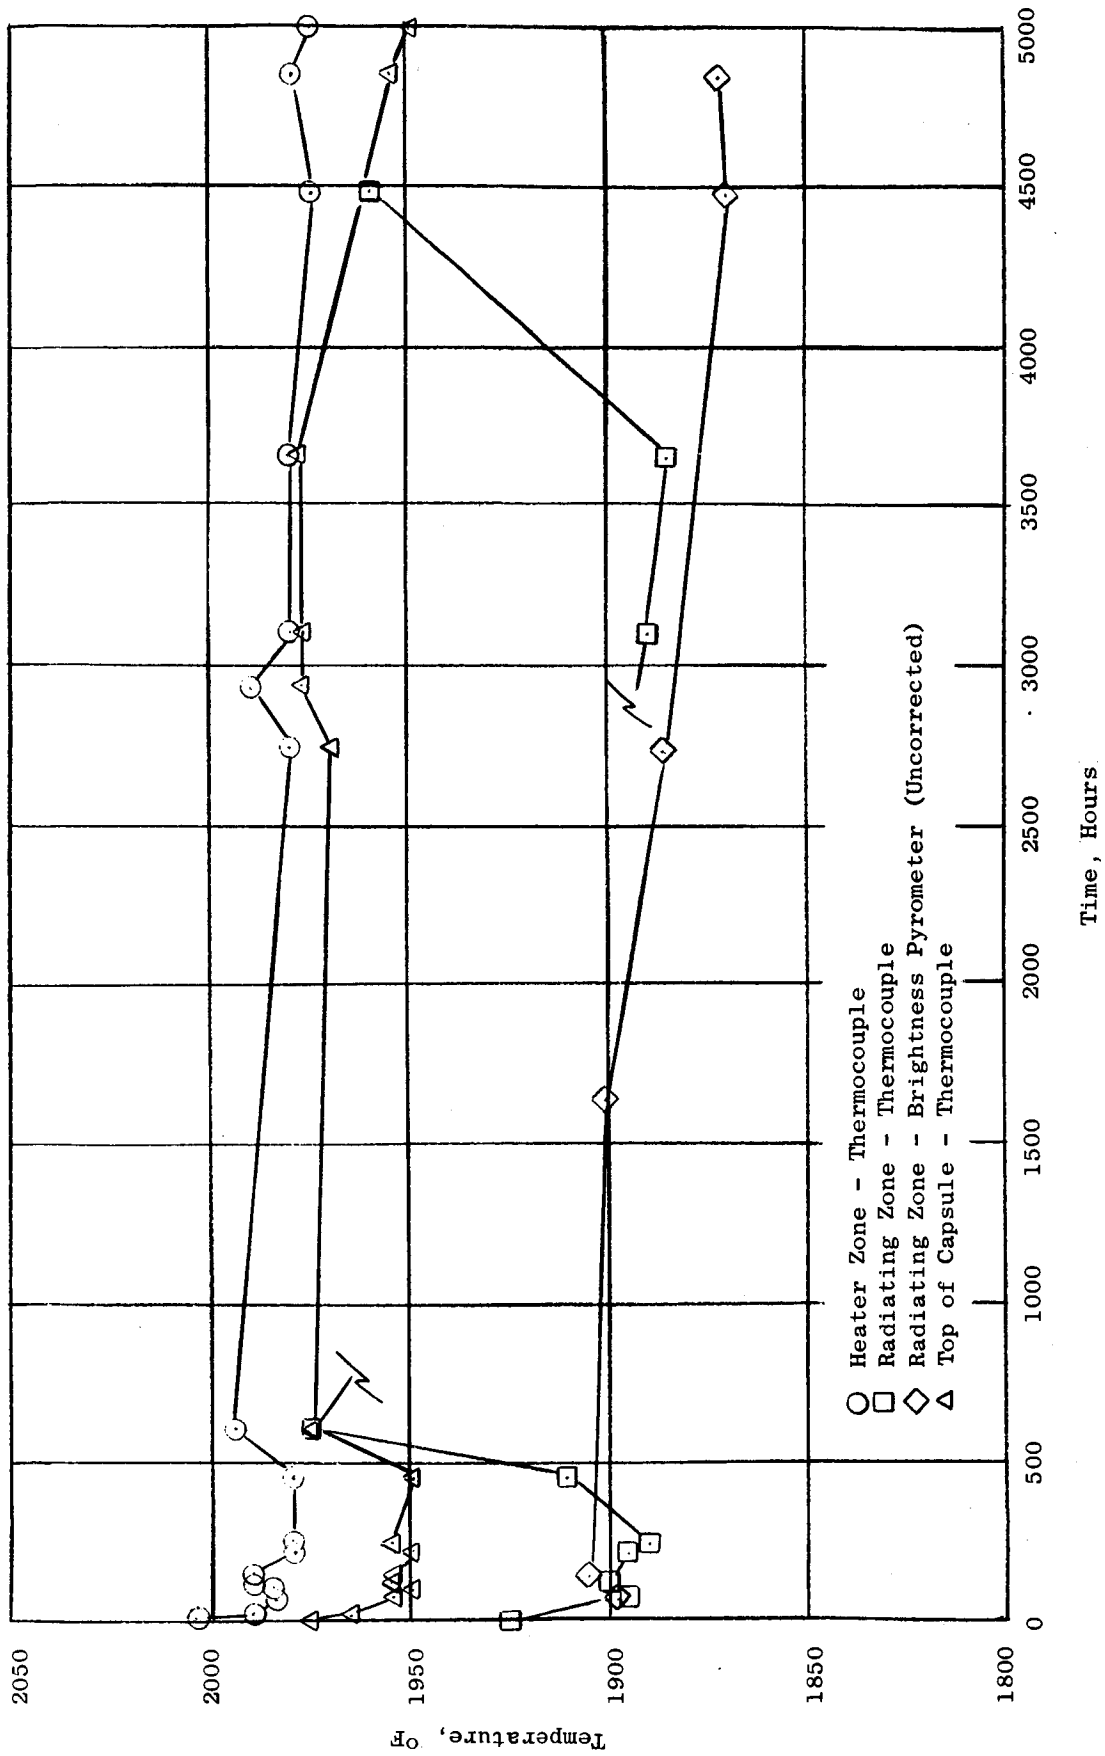
Figure 14. Indicated Temperatures of Reflux Corrosion Capsule #8 (AS-55 Alloy) During 5,000-Hour Exposure to Potassium.
